TRIAL PIT TEST

LAND PARCEL NO. 1

MOONBEAM WALK

Client/Owner : Singapore Land Authority
Conducted by : Hock Lian Building Co. Pte Ltd
Inspected & Certified : Millenniums Consultants
Date : 26 September 2007

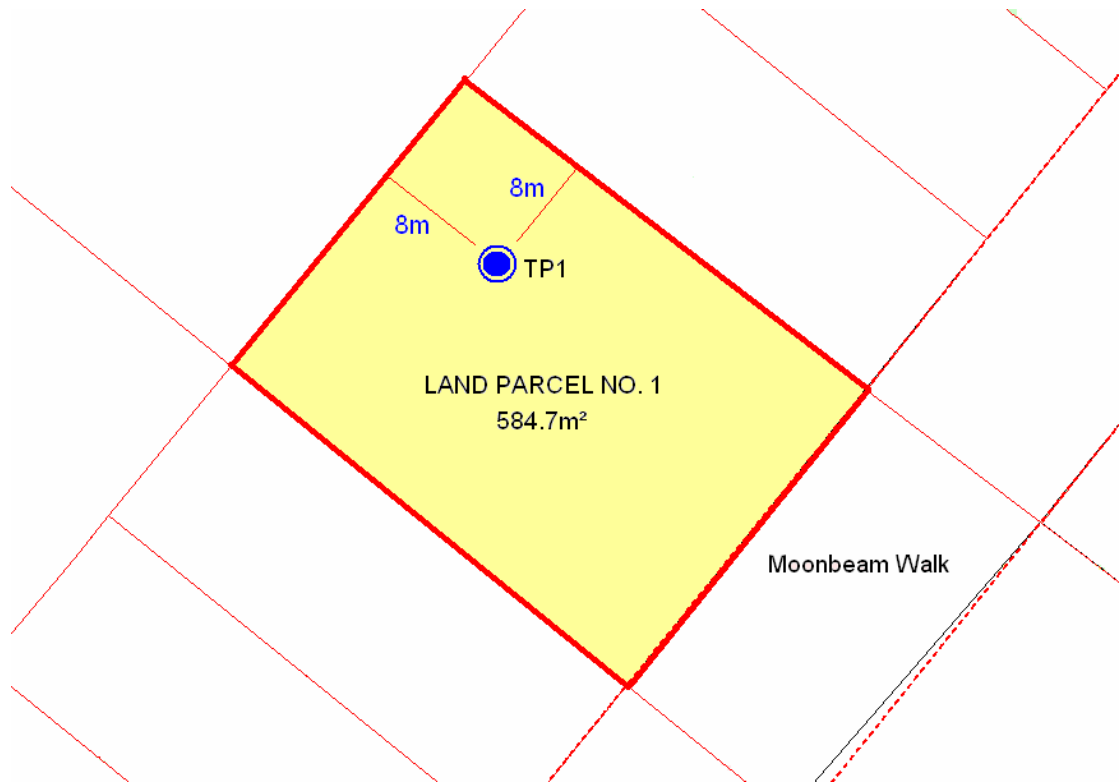
3 TRIAL PIT LOCATION PLAN

A total of 1 trial pit was excavated for approx. 584.70 m² of land at locations shown in the Trial Pits Location Plan (as attached). Prior to the excavation, cable detection has been carried out to confirm location of the services as this is a built up area.

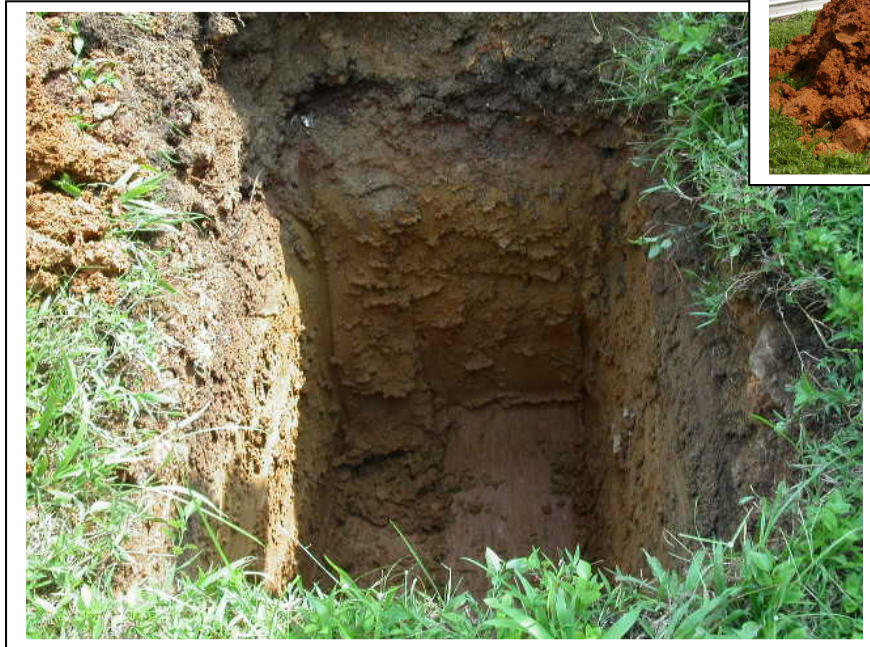
5 FINDINGS

- Location: Land Parcel No. 1 at Moonbeam Walk
- Trial Pit No: 001
- Size: 1.5m length x 1.5m width x 3m depth
- Original State: Land with maintained cow grass turfing

- Soil Condition up to 3 metres: The following materials were not found:
- marine clays
 - peaty clays
 - material from sump
 - large timber pieces
 - tree trunks

- rubber tyres
 - materials susceptible to spontaneous combustion
 - organic municipal waste
 - other industrial and domestic refuse
 - soil of liquid limit exceeding 70 and/or plasticity index exceeding 35

- Water Table: No sign of high water table

At the only trial pit that we have inspected, we found no signs of illegal dumping and water table. The soil condition is good.
