TRIAL PIT TEST

LAND PARCEL NO. 7

BRADDELL ROAD

TRIAL PIT TEST FOR LAND PARCEL NO. 7 AT BRADDELL ROAD

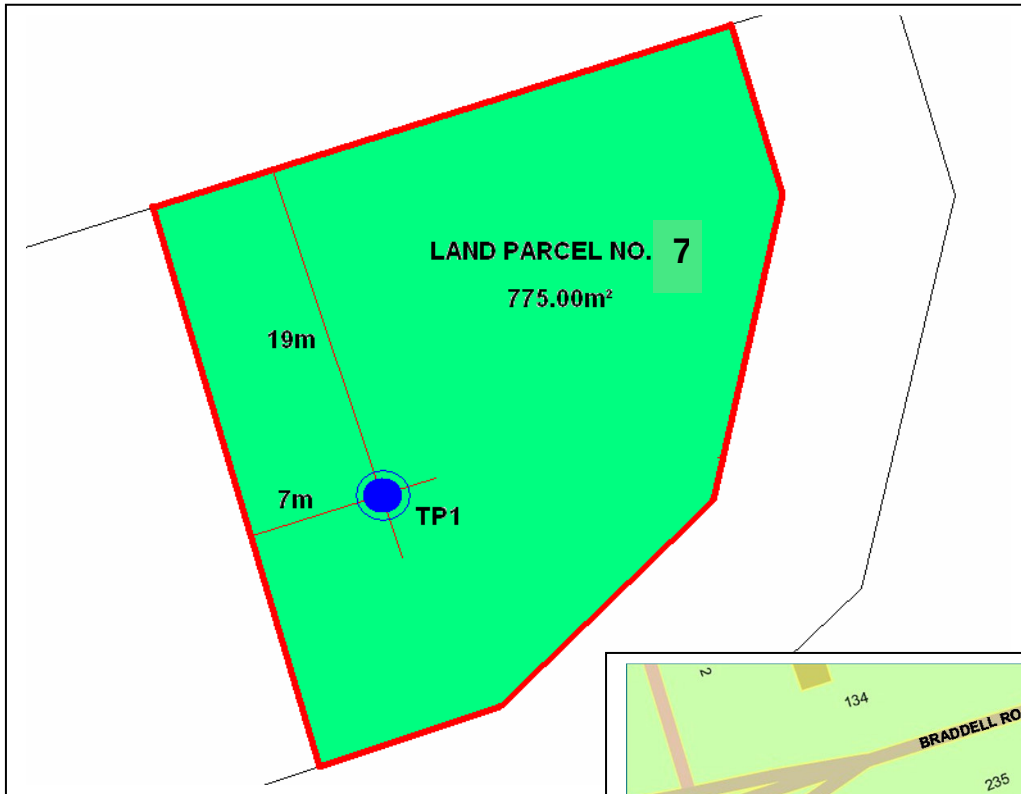
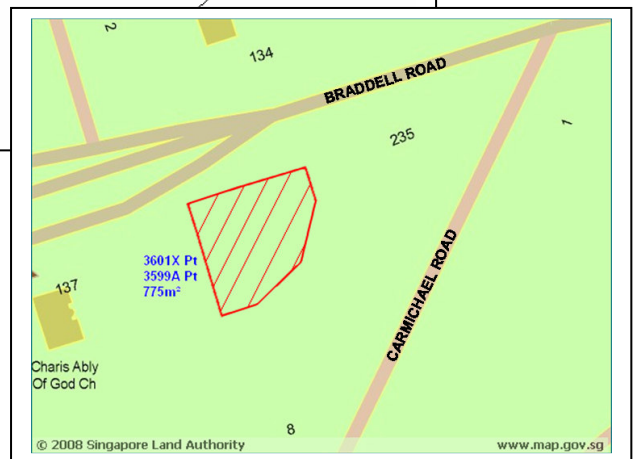
3 TRIAL PIT LOCATION PLAN

A total of 1 trial pit was excavated for approx. 775.00m² of land at location shown in the Trial Pit Location Plan (as attached). Prior to the excavation, cable detection has been carried out to confirm location of the services as this is a built up area.

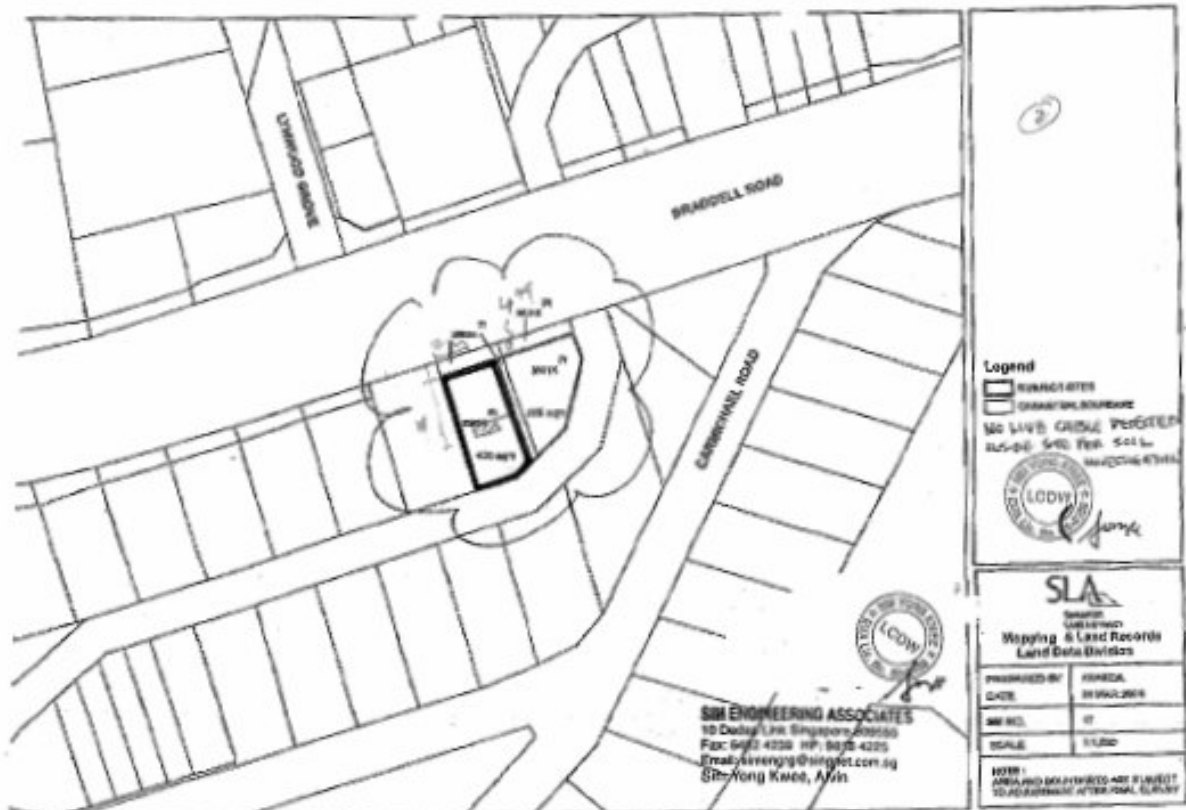
Braddell Road / Camichael Road lot 3599A x 3601 X MK17.

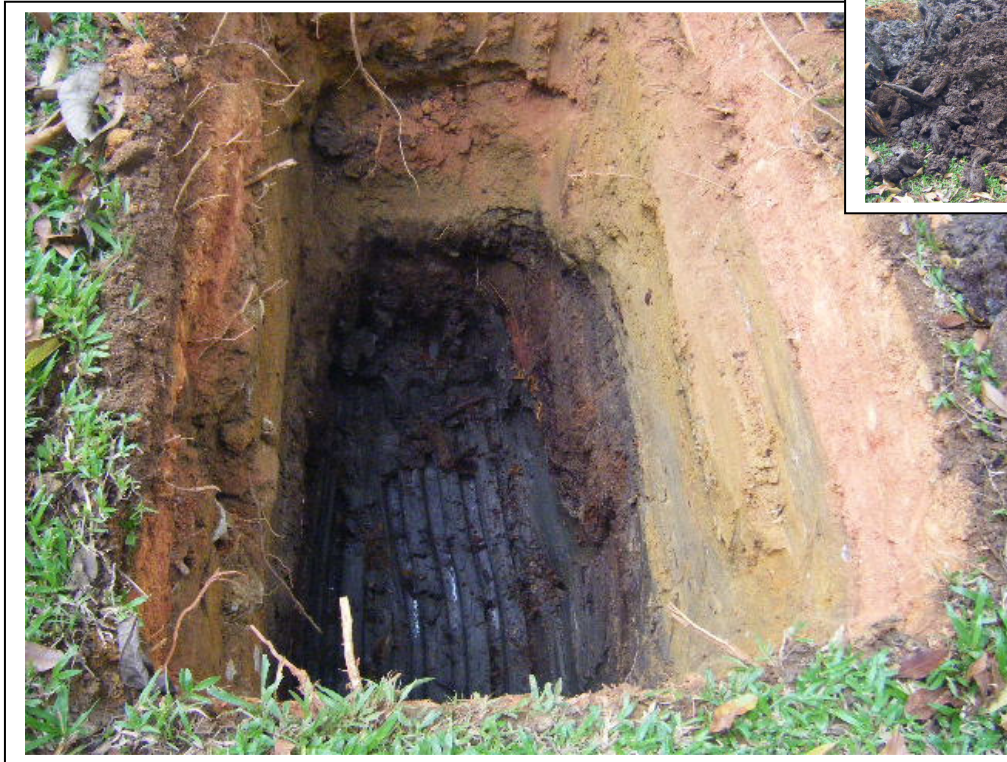
Location: Land Parcel No. 7 at Braddell Road
Trial Pit No: 001
Size: 1.5m length x 1.5m width x 3m depth
Original State: Land with maintained cow grass turfing

TRACES OF DEBRIS FOUND IN TRIAL PIT

Concrete cube

Rock

Tree trunk

Tree branch

At the only trial pit that we have inspected, we found some debris within 1 metre depth from ground level. No sign of water table found within the first 3 metres from ground level. The soil condition is good.
