## **TRIAL PIT TEST**

**LAND PARCEL NO. 5**

**BEDOK CLOSE**

**TRIAL PIT TEST FOR LAND PARCEL NO. 5 AT BEDOK CLOSE**

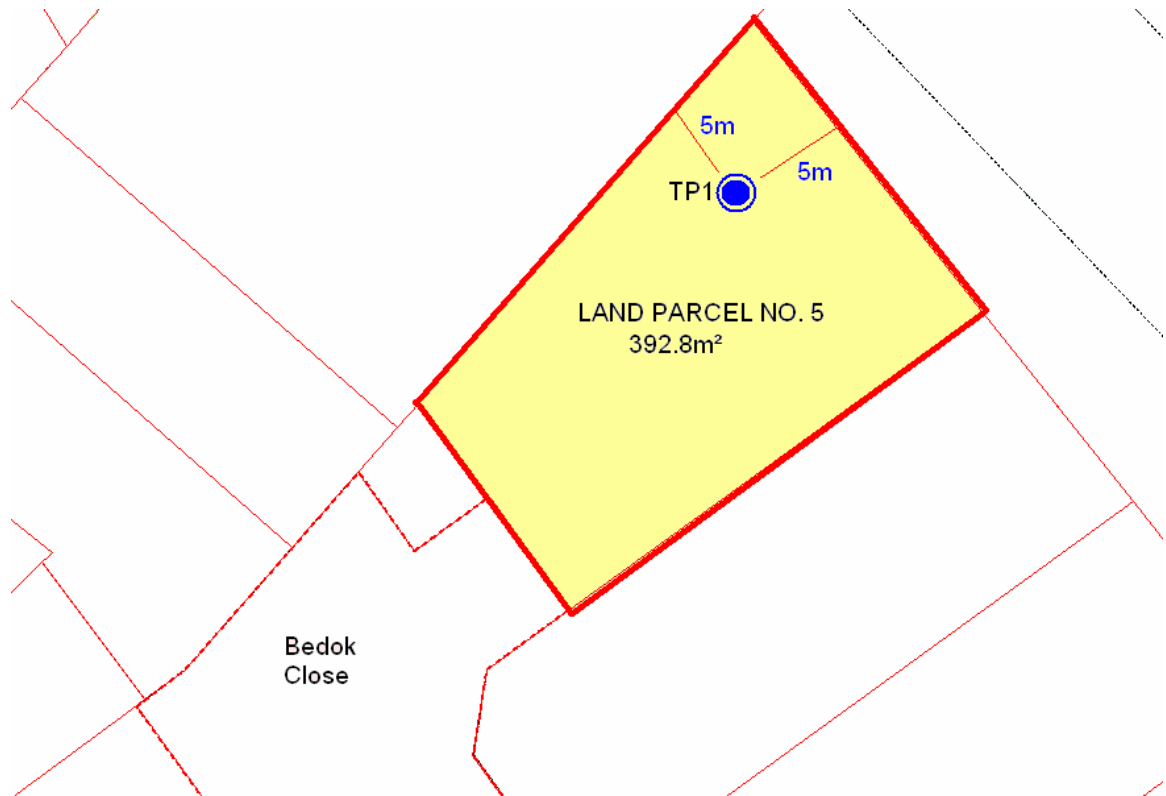
### 3 TRIAL PIT LOCATION PLAN

A total of 1 trial pit was excavated for approx. 392.80 m<sup>2</sup> of land at location shown in the Trial Pit Location Plan (as attached). Prior to the excavation, cable detection has been carried out to confirm location of the services as this is a built up area.

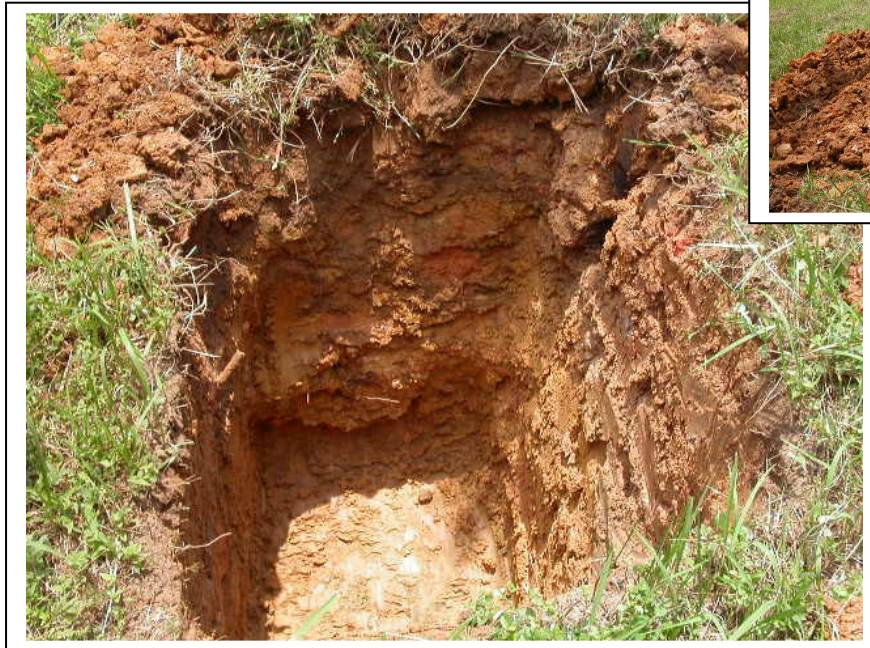
- Location: Land Parcel No. 5 at Bedok Close
- Trial Pit No: 001
- Size: 1.5m length x 1.5m width x 3m depth
- Original State: Land with maintained cow grass turfing

- Soil Condition up to 3 metres: The following materials were not found:
- marine clays
  - peaty clays
  - material from sump
  - large timber pieces
  - tree trunks

- rubber tyres
  - materials susceptible to spontaneous combustion
  - organic municipal waste
  - other industrial and domestic refuse
  - soil of liquid limit exceeding 70 and/or plasticity index exceeding 35

- Water Table: No sign of high water table

At the only trial pit that we have inspected, we found no signs of illegal dumping and water table. The soil condition is good.
