## **TRIAL PIT TEST**

**LAND PARCEL NO. 6**

**SOMME ROAD**

Client/Owner : Singapore Land Authority  
Conducted by : Hock Lian Building Co. Pte Ltd  
Inspected & Certified : Millenniums Consultants  
Date : 26 September 2007

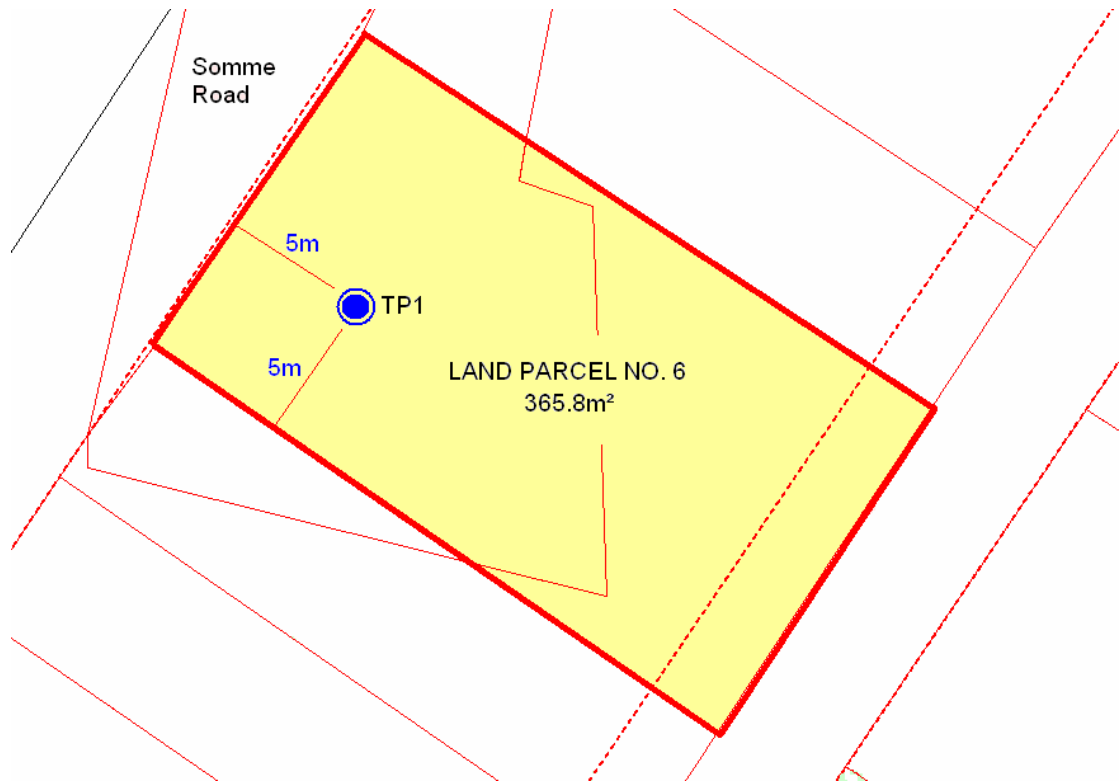
### 3 TRIAL PIT LOCATION PLAN

A total of 1 trial pit was excavated for approx. 365.80m<sup>2</sup> of land at location shown in the Trial Pit Location Plan (as attached). Prior to the excavation, cable detection has been carried out to confirm location of the services as this is a built up area.

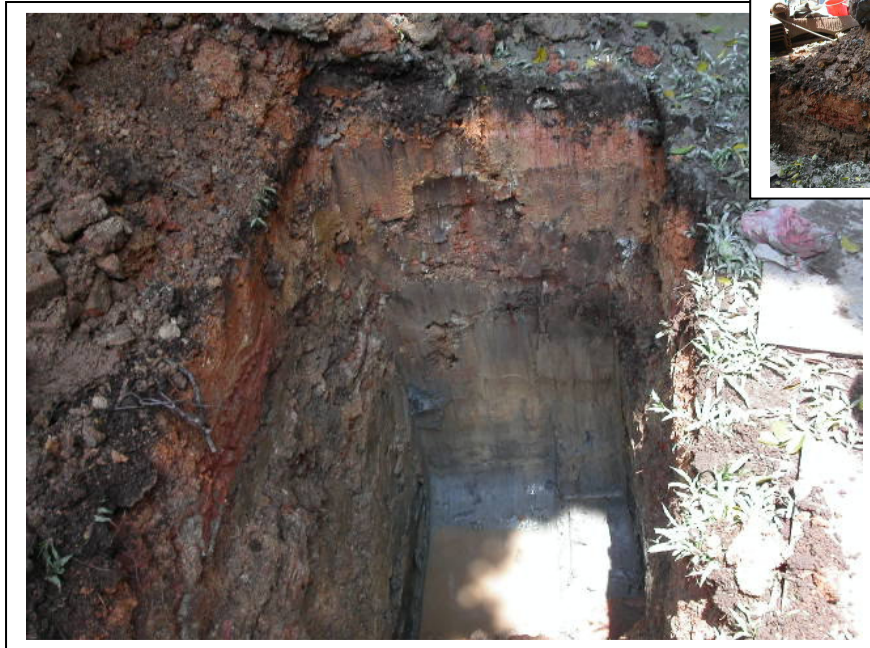
Trial Pit No: 001

Size: 1.5m length x 1.5m width x 3m depth

Original State: Land with maintained cow grass turfing

Soil Condition up to 3 metres: The following materials were not found:

- material from sump
- large timber pieces
- tree trunks
- rubber tyres
- materials susceptible to spontaneous combustion
- organic municipal waste
- other industrial and domestic refuse
- soil of liquid limit exceeding 70 and/or plasticity index exceeding 35
- materials having moisture content greater than the maximum permitted for such materials in the Contract, unless otherwise permitted by the Superintending Officer
- rock, which are hard material whose geological nature is to be regarded as such and individual boulders exceeding 0.20m<sup>3</sup> or other masses of hard natural material which necessitates the use of blasting or approved pneumatic tools for their removal.

Water Table: No sign of high water table

At the only trial pit that we have inspected, we found no signs of illegal dumping and water table. The soil condition is good.

However, clay composition is found at approx 0.5metre below ground level.
