TRIAL PIT TEST

LAND PARCEL NO. 4

JALAN PARI BURONG / BEDOK NORTH AVE 4

Client/Owner : Singapore Land Authority
Conducted by : Seng & Keng Construction Pte Ltd
Inspected & Certified : Millenniums Consultants
Date : 05 June 2008

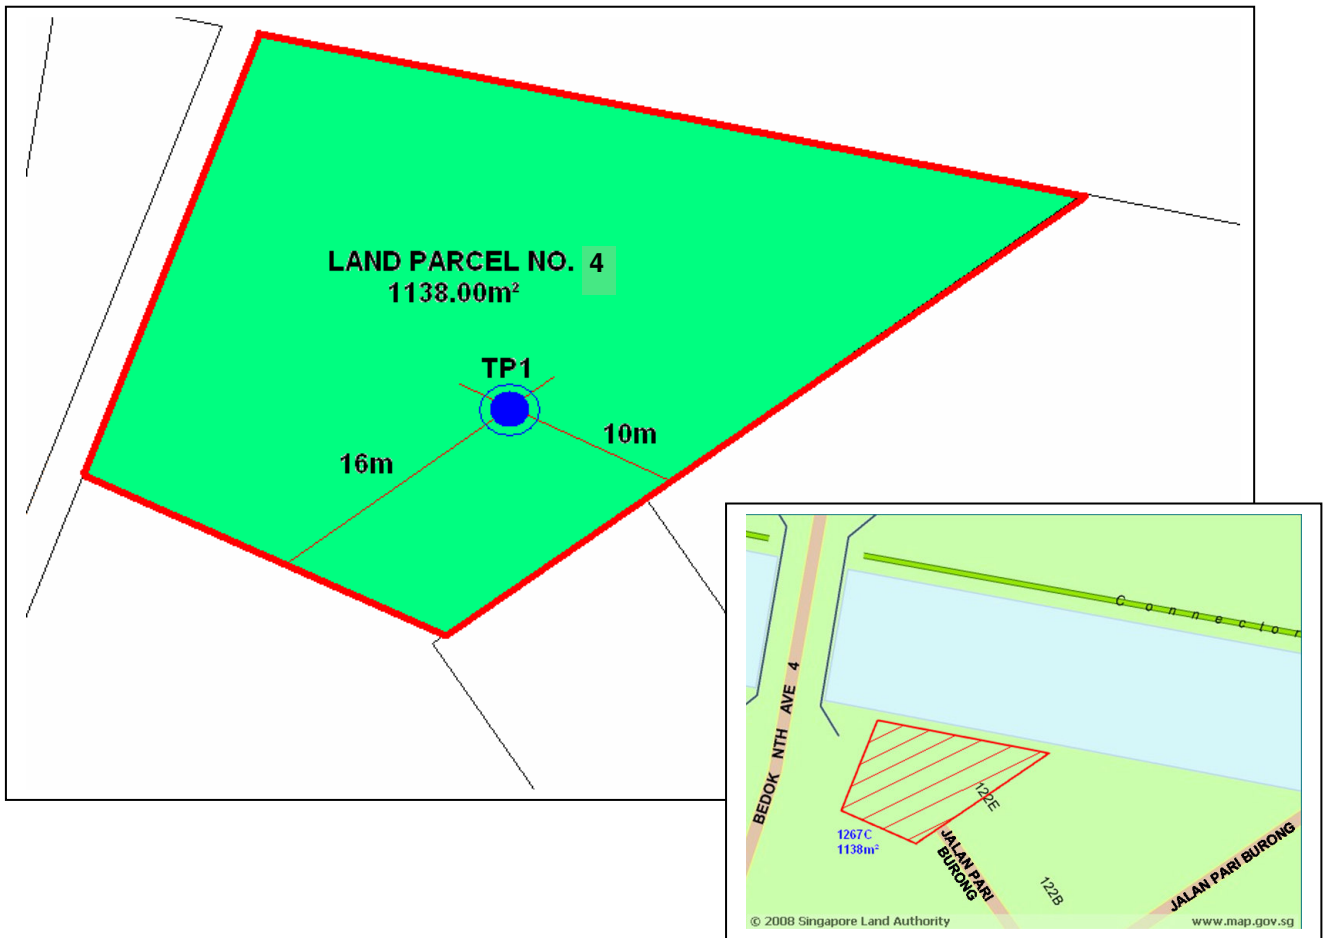
3 TRIAL PIT LOCATION PLAN

A total of 1 trial pit was excavated for approx. 1,138.00m² of land at location shown in the Trial Pit Location Plan (as attached). Prior to the excavation, cable detection has been carried out to confirm location of the services as this is a built up area.

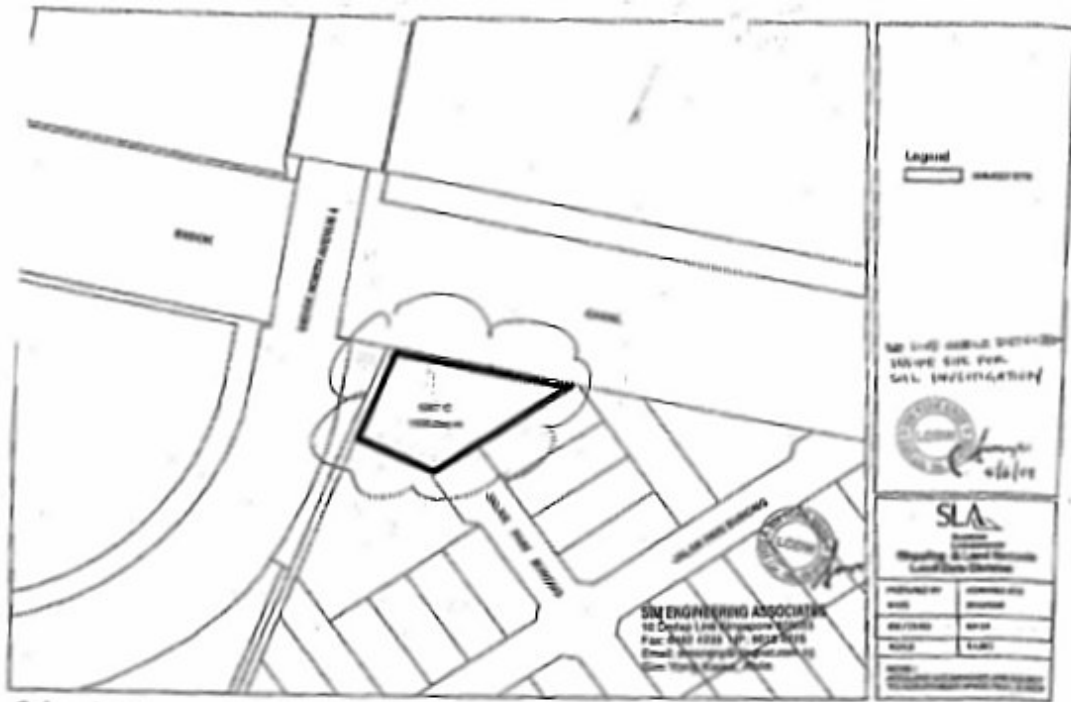
Jalan Pui Hwang / Bedok North Ave 4 Lot 1267 C MK 28 .

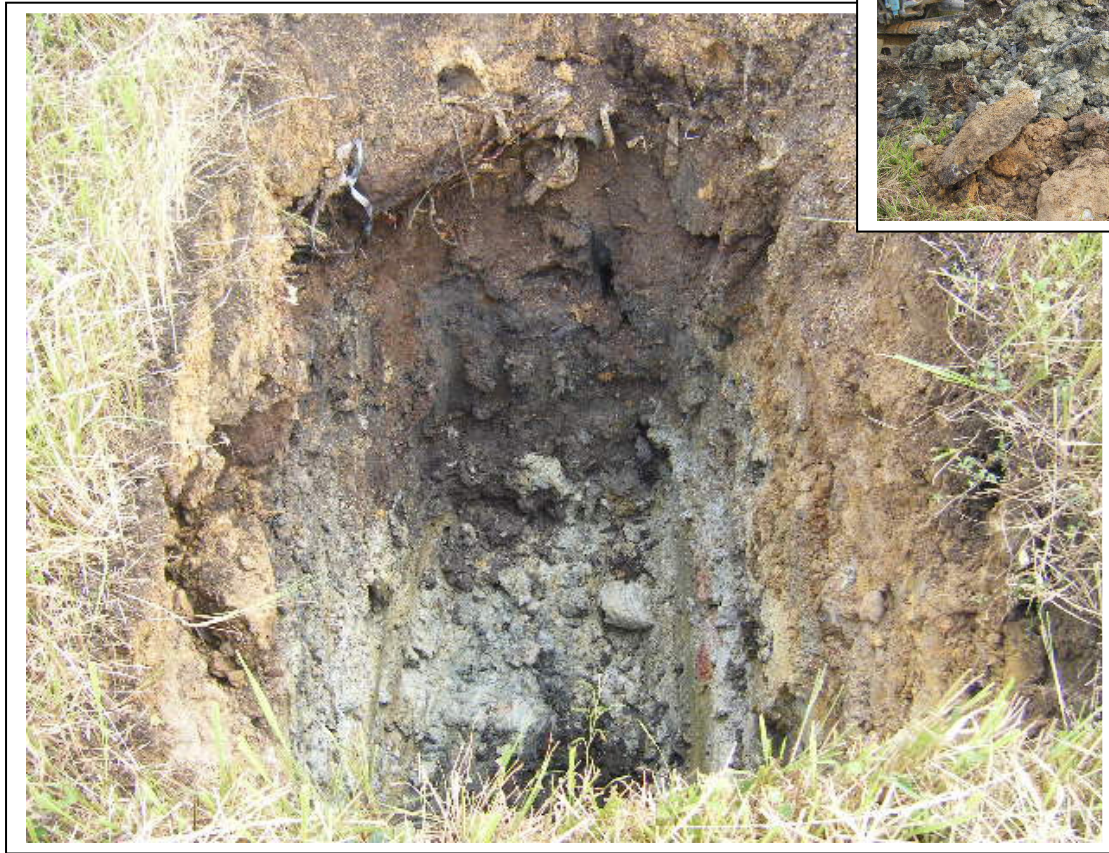
Trial Pit No: 001

Location: Land Parcel No. 4 at Jalan Pari Burong / Bedok North Ave 4

Size: 1.5m length x 1.5m width x 3m depth

Original State: Land with maintained cow grass turfing

TRACES OF DEBRIS FOUND IN TRIAL PIT

Large Rocks

Timber pieces

Industrial refuse

- Soil Condition up to 3 metres: The following materials were not found:
- marine clays
 - peaty clays
 - material from sump
 - tree trunks
 - rubber tyres
 - materials susceptible to spontaneous combustion
 - organic municipal waste
 - soil of liquid limit exceeding 70 and/or plasticity index exceeding 35
 - materials having moisture content greater than the maximum permitted for such materials in the Contract, unless otherwise permitted by the Superintending Officer
- Water Table: No sign of water table

At the only trial pit that we have inspected, we found some debris within 1 metre depth from ground level. No sign of water table found within the first 3 metres from ground level. The soil condition is good.
