TRIAL PIT TEST

LAND PARCEL NO. 1

UPPER EAST COAST ROAD

TRIAL PIT TEST FOR LAND PARCEL NO. 1 AT UPPER EAST COAST ROAD

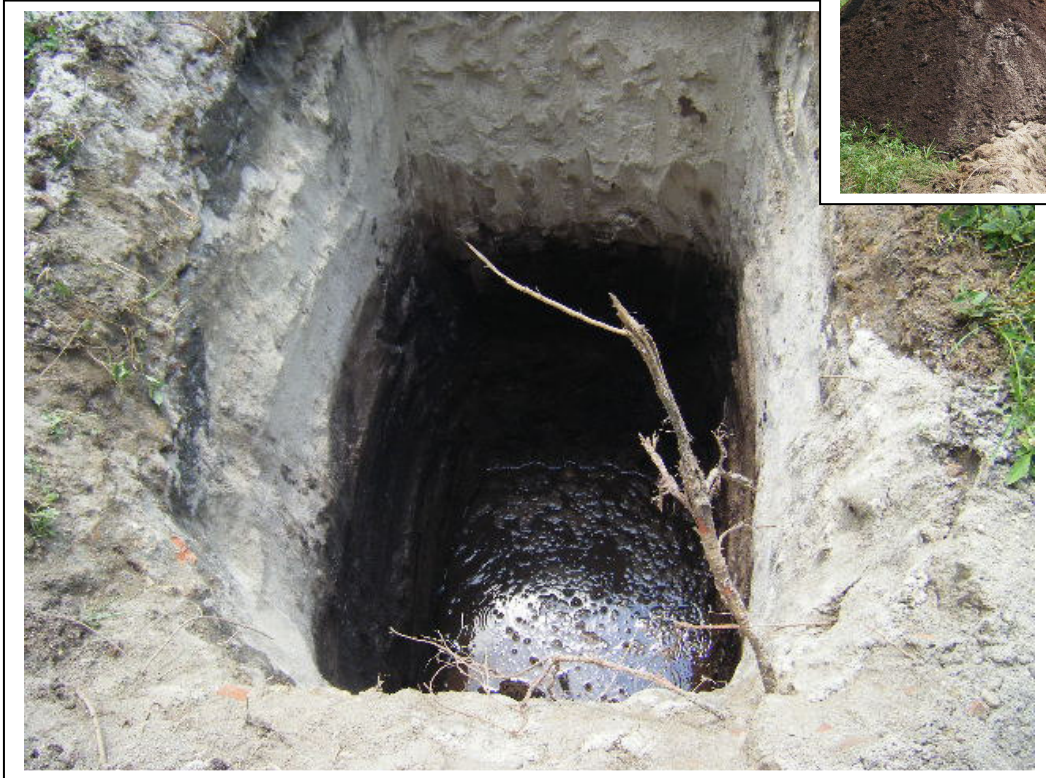
Location: Land Parcel No. 1 at Upper East Coast Road
Trial Pit No: 001
Size: 1.5m length x 1.5m width x 3m depth
Original State: Land with maintained cow grass turfing

TRACES OF DEBRIS FOUND IN TRIAL PIT

- Soil Condition up to 3 metres:
- The following materials were not found:
- marine clays
 - peaty clays
 - material from sump
 - large timber pieces
 - tree trunks
 - rubber tyres
 - materials susceptible to spontaneous combustion
 - organic municipal waste
 - other industrial and domestic refuse
 - soil of liquid limit exceeding 70 and/or plasticity index exceeding 35
 - materials having moisture content greater than the maximum permitted for such materials in the Contract, unless otherwise permitted by the Superintending Officer
 - rock, which are hard material whose geological nature is to be regarded as such and individual boulders exceeding 0.20m³ or other masses of hard natural material which necessitates the use of blasting or approved pneumatic tools for their removal.
- Water Table: The water table was observed at approximately 2.9m below existing ground level

At the only trial pit that we have inspected, we found some debris within 1 metre depth from ground level. Water table found at approximately 2.9 metres from ground level. The soil condition is good.
